A RAILROAD TO BE REBUILT.

By your direction, there has been prepared and is submitted herewith a record of the Flood of March, 1913, and its disruption of the service of your Lines, in such detail as to give a general idea of the extent of the damage and the progress of the work of restoration.

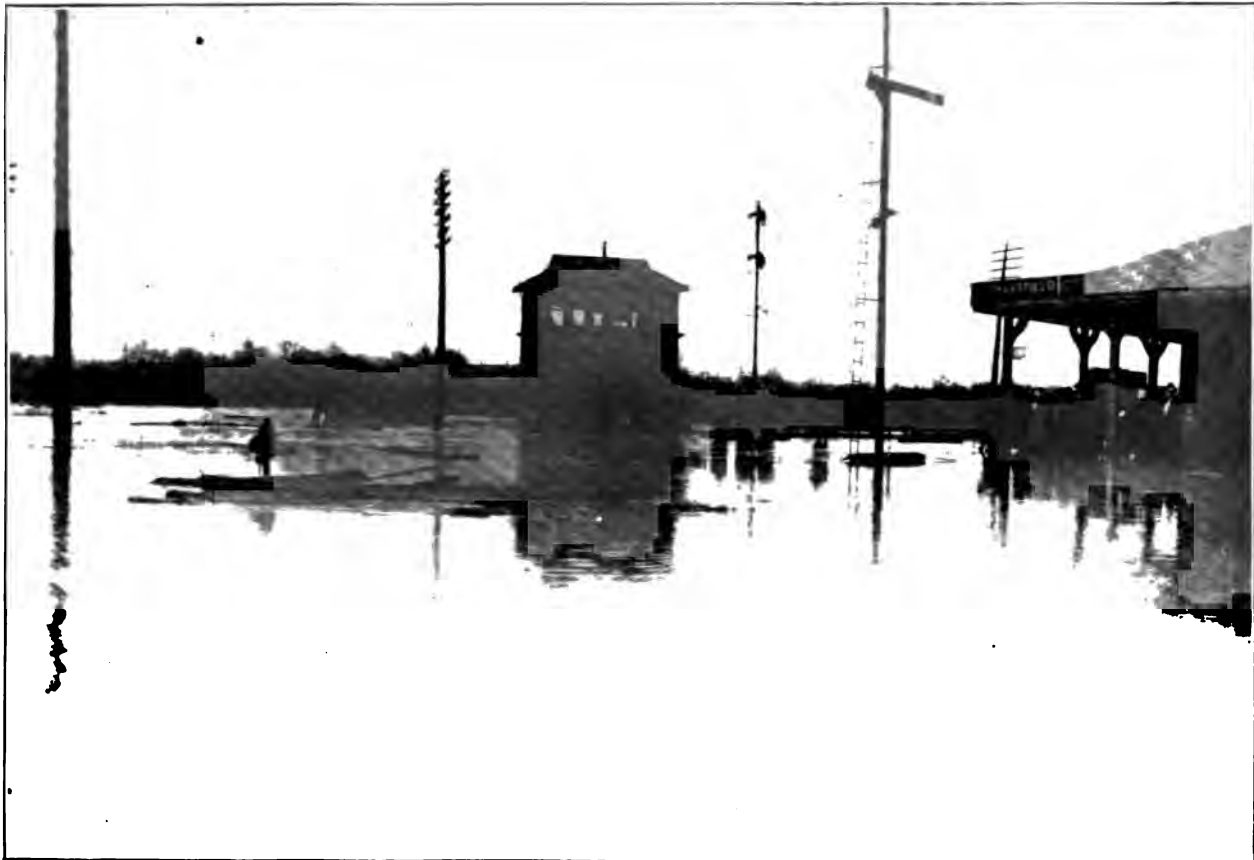
Sharon, Pa.

West side Shenango River, near Budd Avenue.

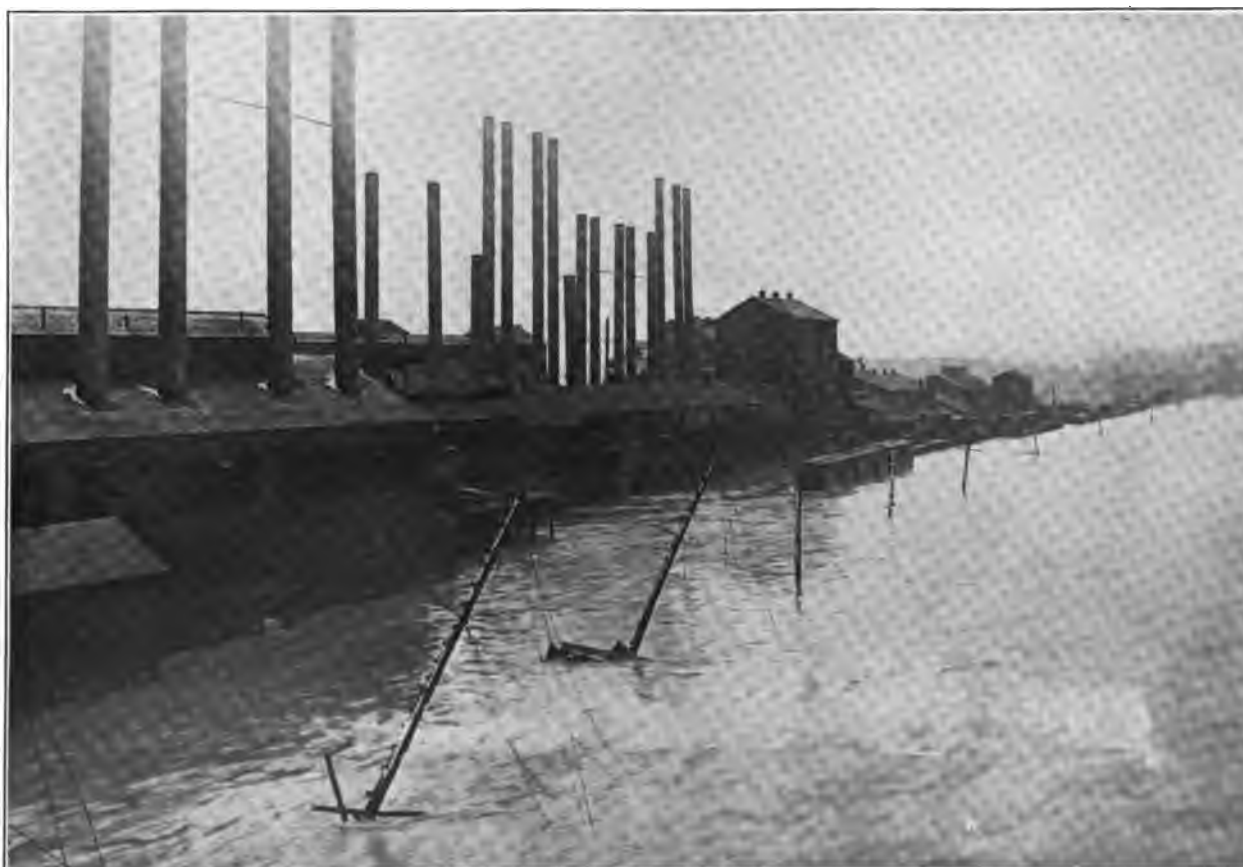
Pennsylvania Lines tracks under water, B. & O. S. W. bridge weighted down.
Interlocking tower at crossing about one-half story under water.

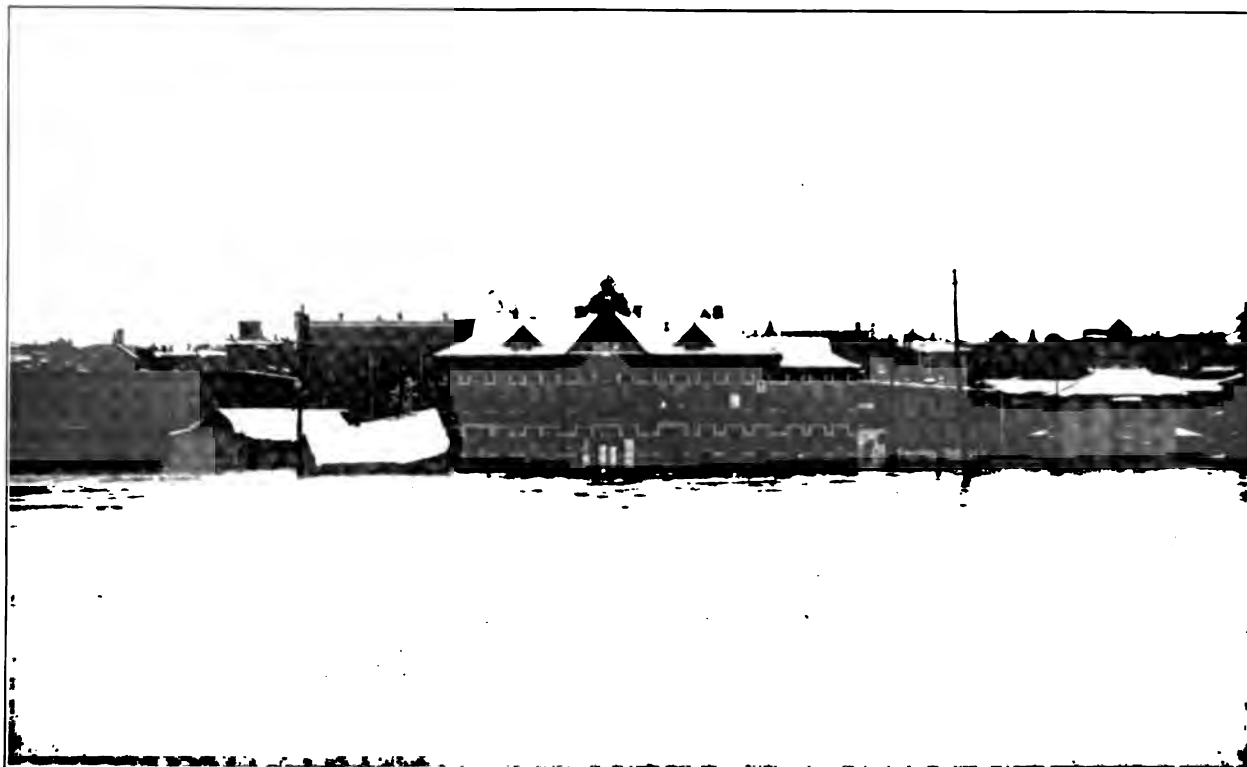
Water had fallen 10 inches, but roadbed was later washed out from four to eight feet deep for a distance of 125 feet.

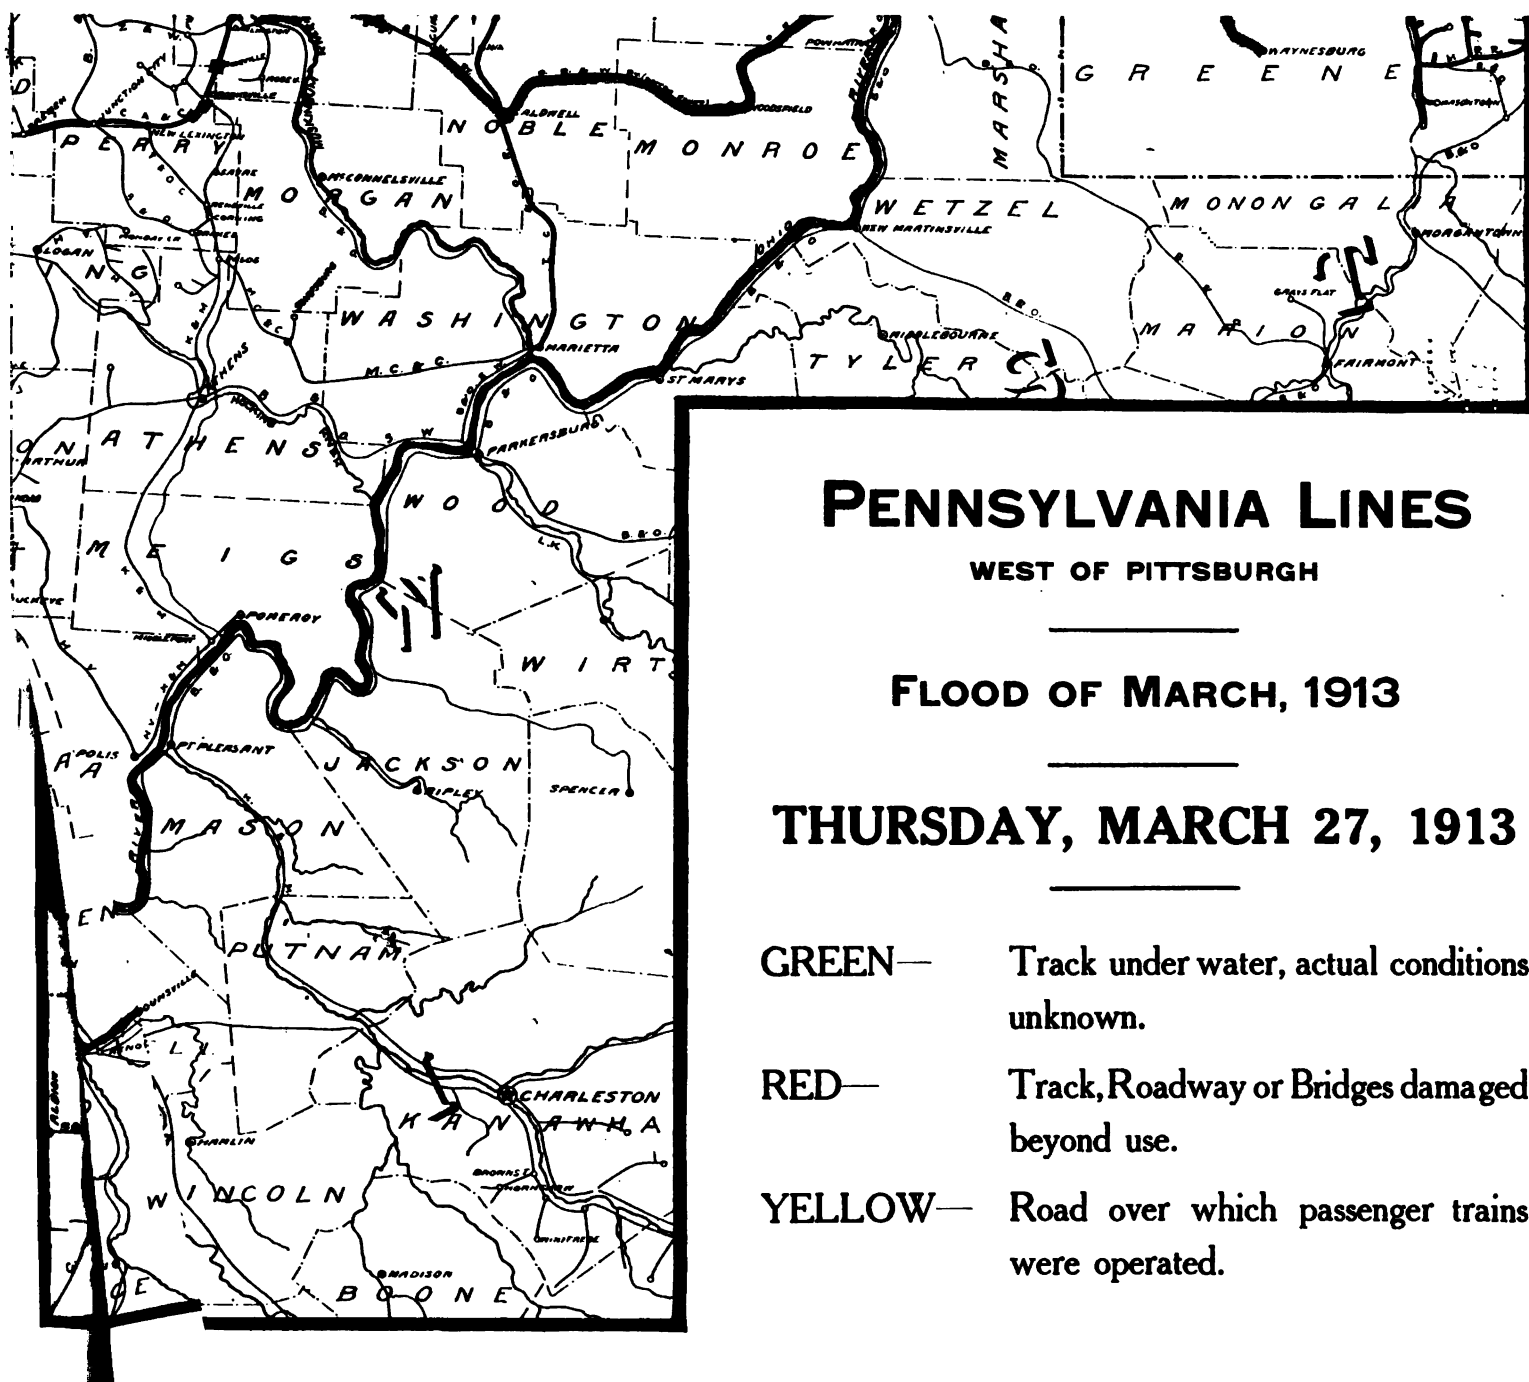
Zanesville, Ohio.

Water at highest—"Y" bridge at junction of Muskingum and Licking rivers completely submerged.

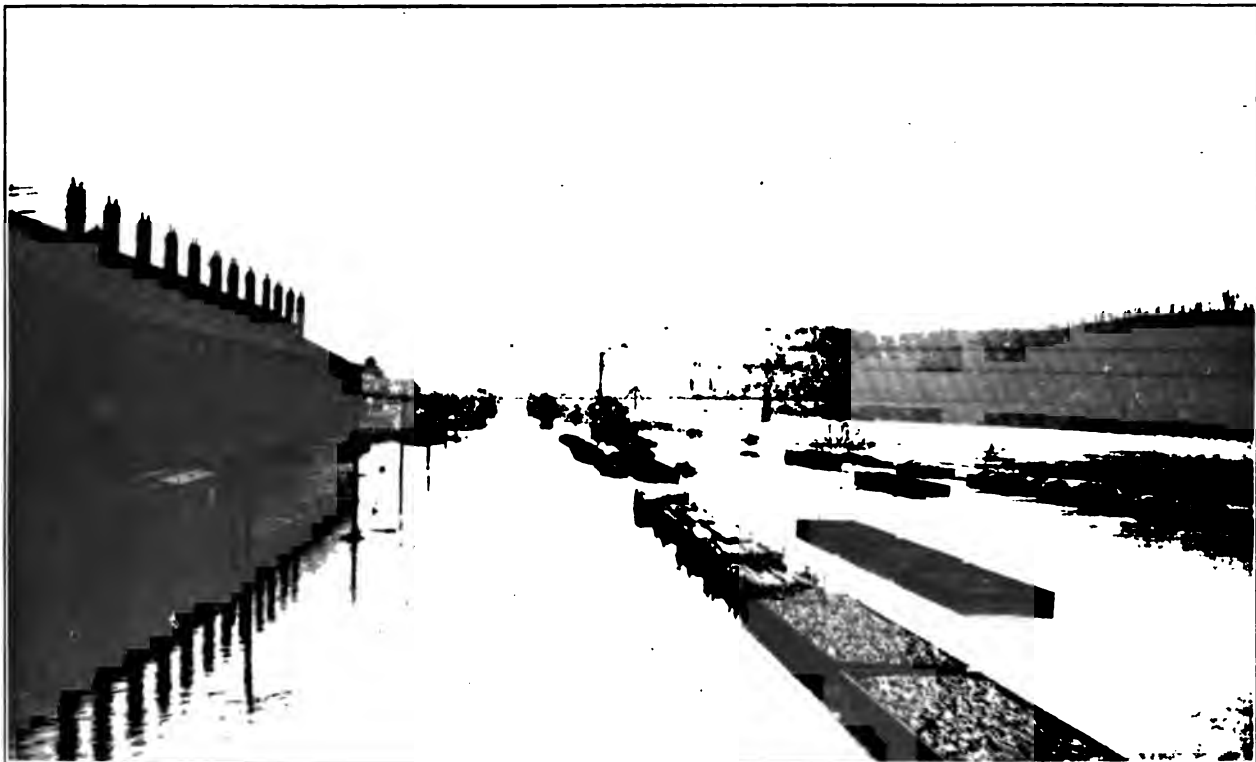
Steubenville, Ohio.

Rear of buildings which front on C. & P. Division main tracks, between passenger and freight stations.

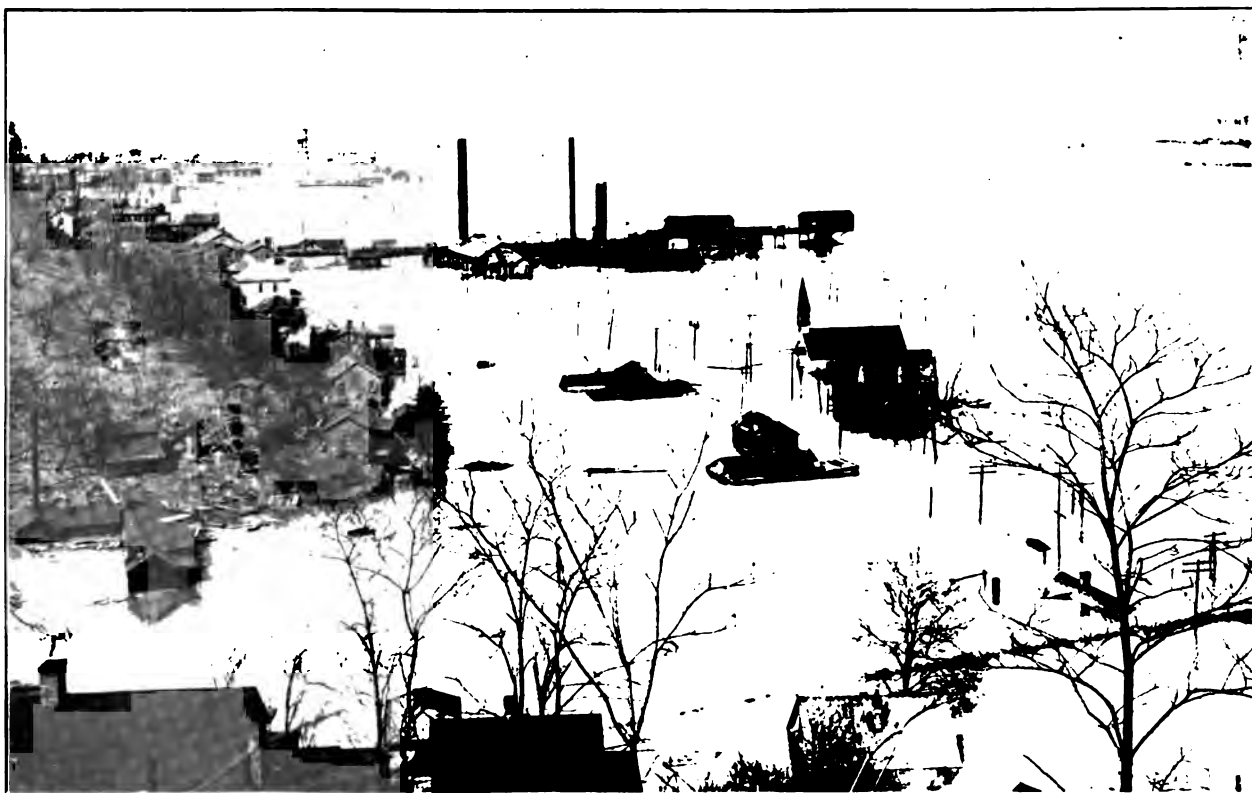
Steubenville, Ohio.

Cleveland & Pittsburgh Division at Pope Tin Plate Mill; main tracks
between telegraph pole line and hopper cars.

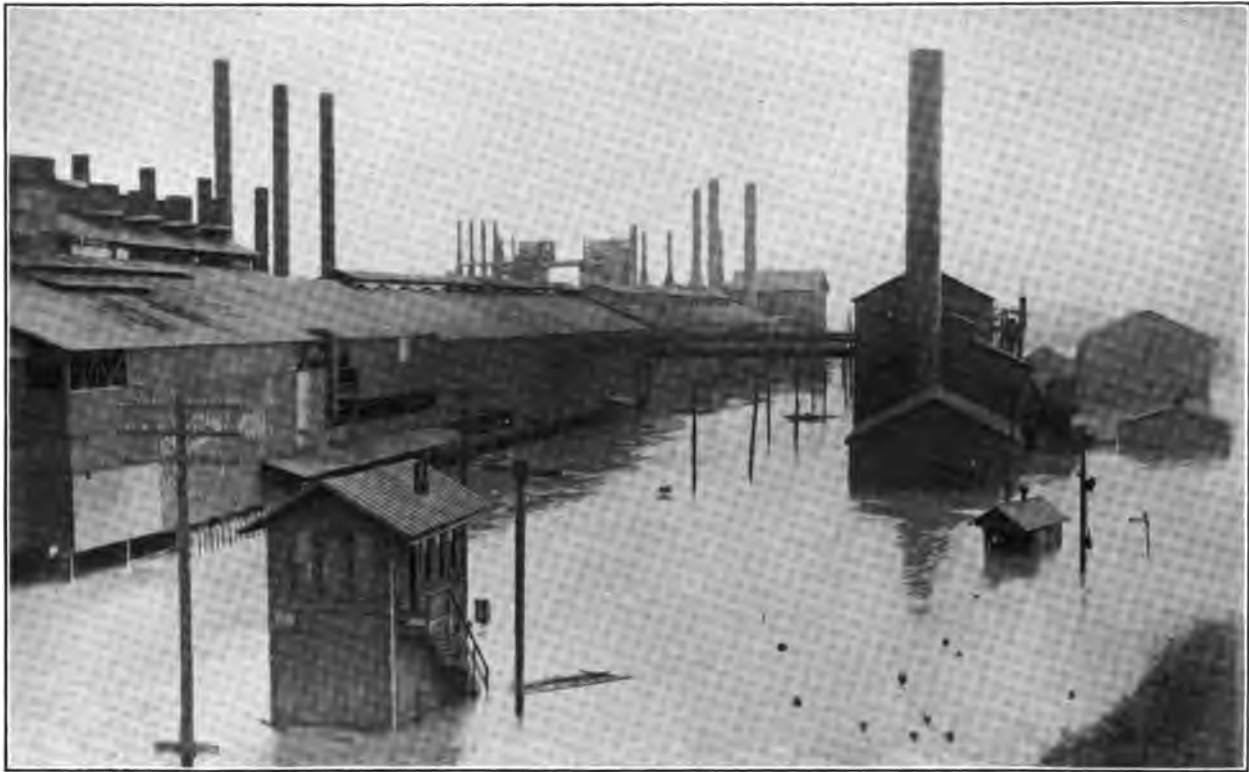
Bellaire, Ohio.

Ohio River about crest—had probably receded a foot or two.

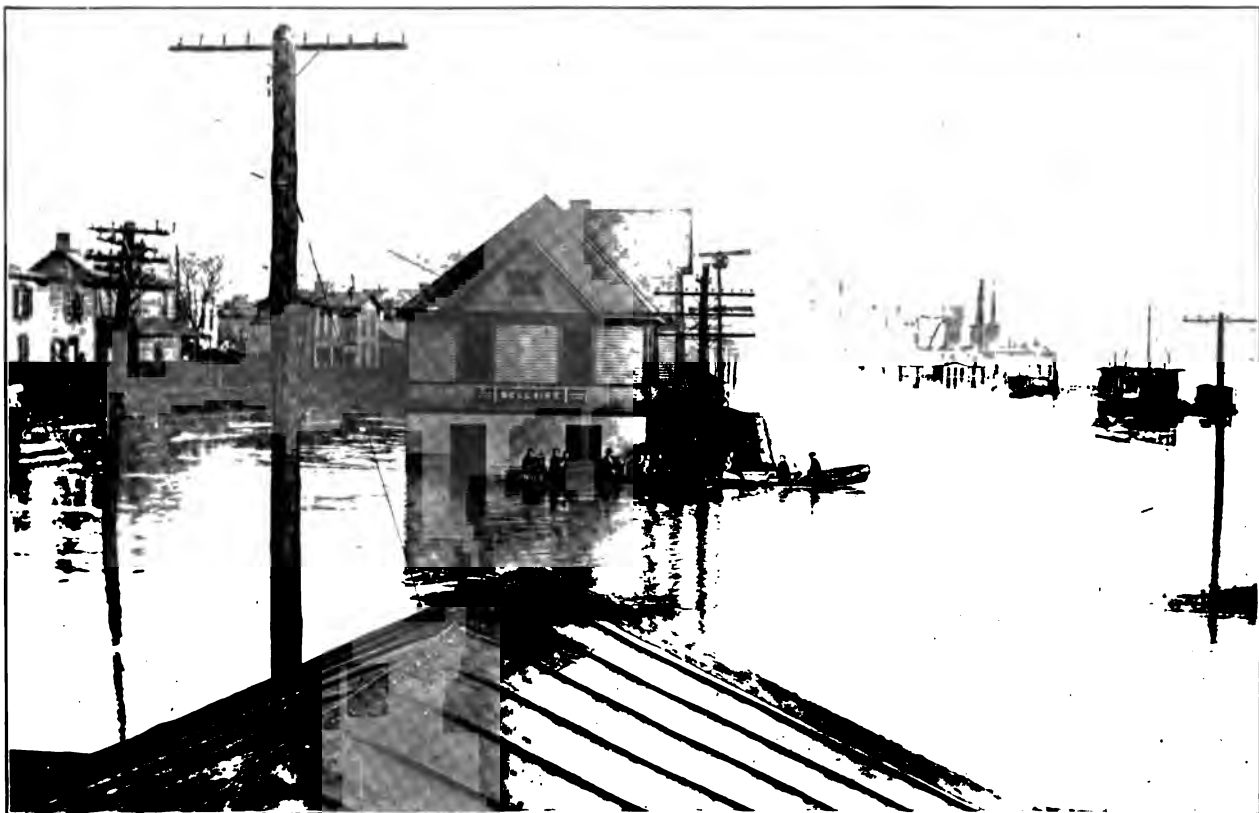
Bellaire, Ohio.

Tower and target at B. & O. crossing in foreground. C. & P. Division tracks parallel telegraph pole line between buildings.

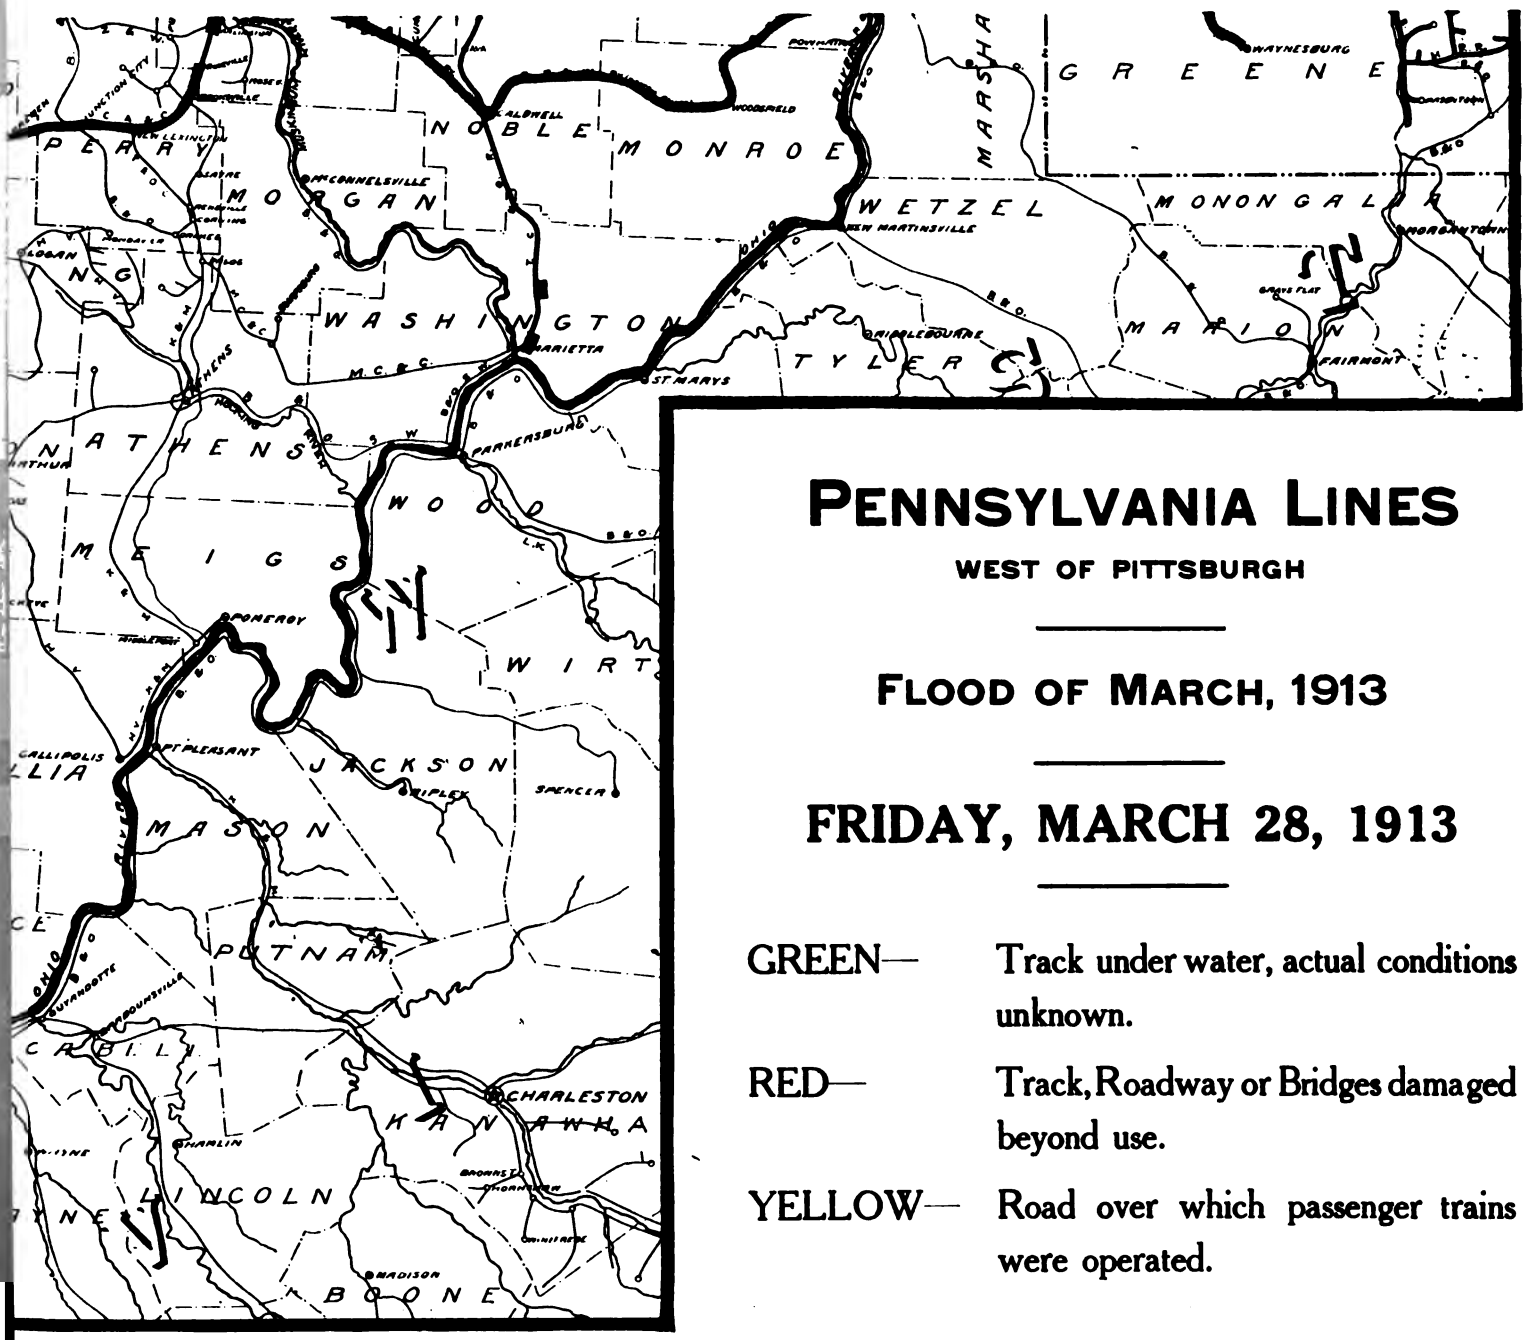
Bellaire, Ohio.

Westward end of Station, Carnegie Steel Plant in distance.

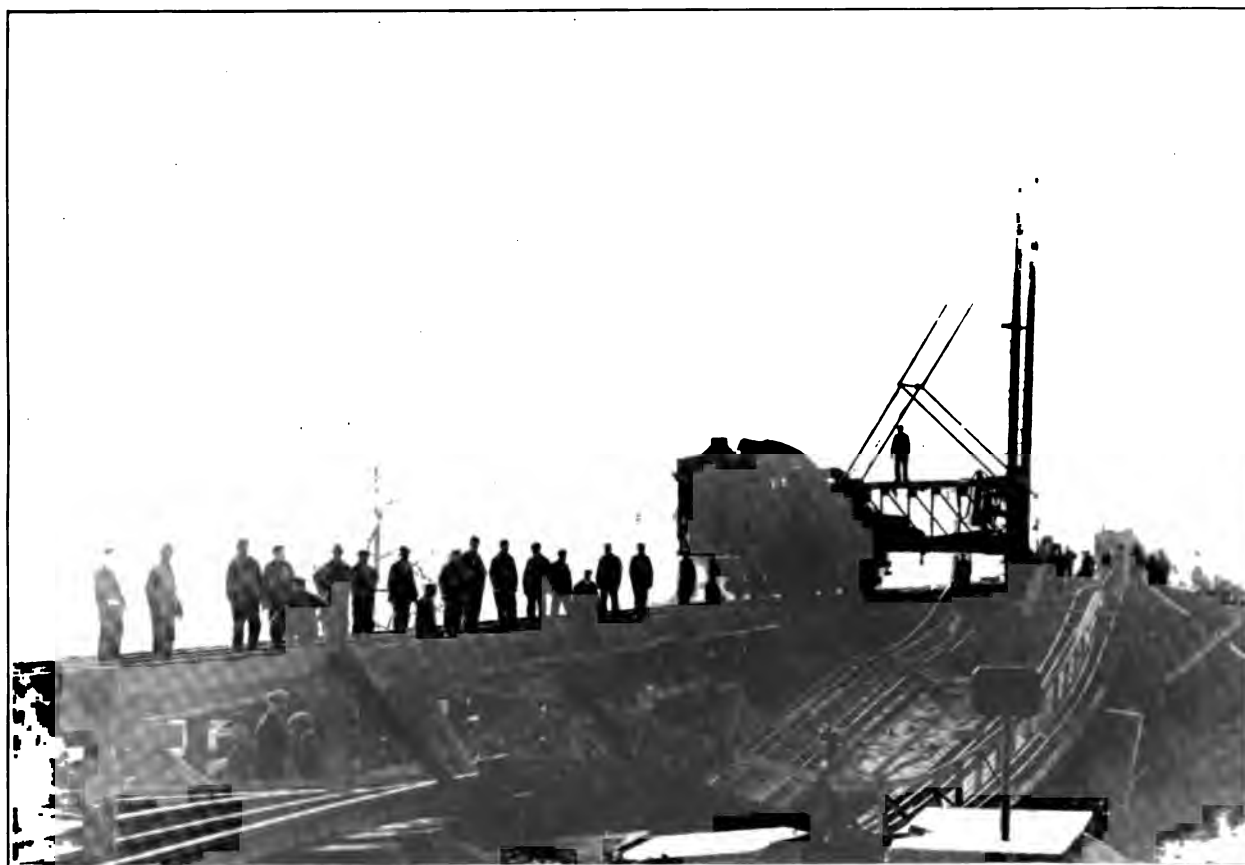
Bridge No. 144, over Black Fork. Replacing approach, which had been washed out for about 75 feet.

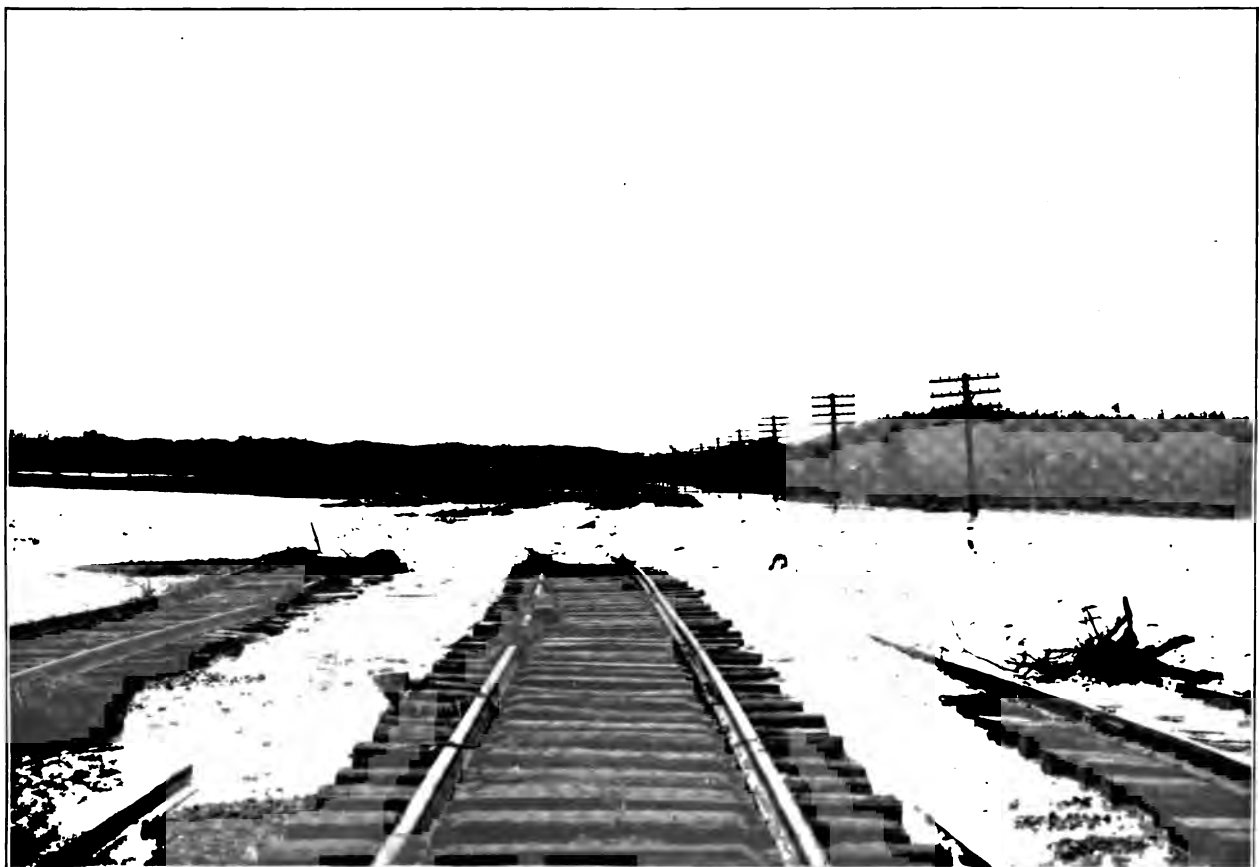
Port Washington, Ohio, west of.

View east from "DG" Tower. Water had fallen 16 inches.

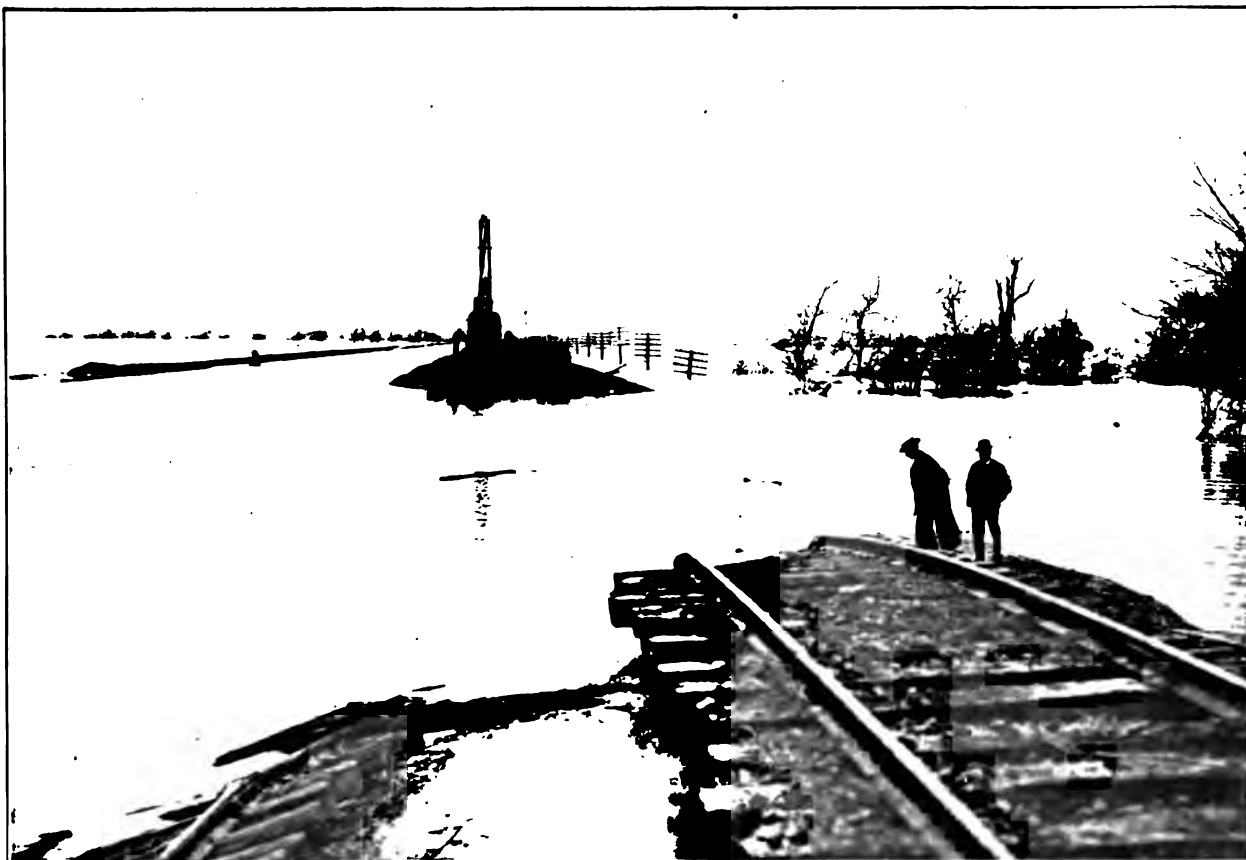
Coshocton, Ohio, east of.

Looking east at "Clow."

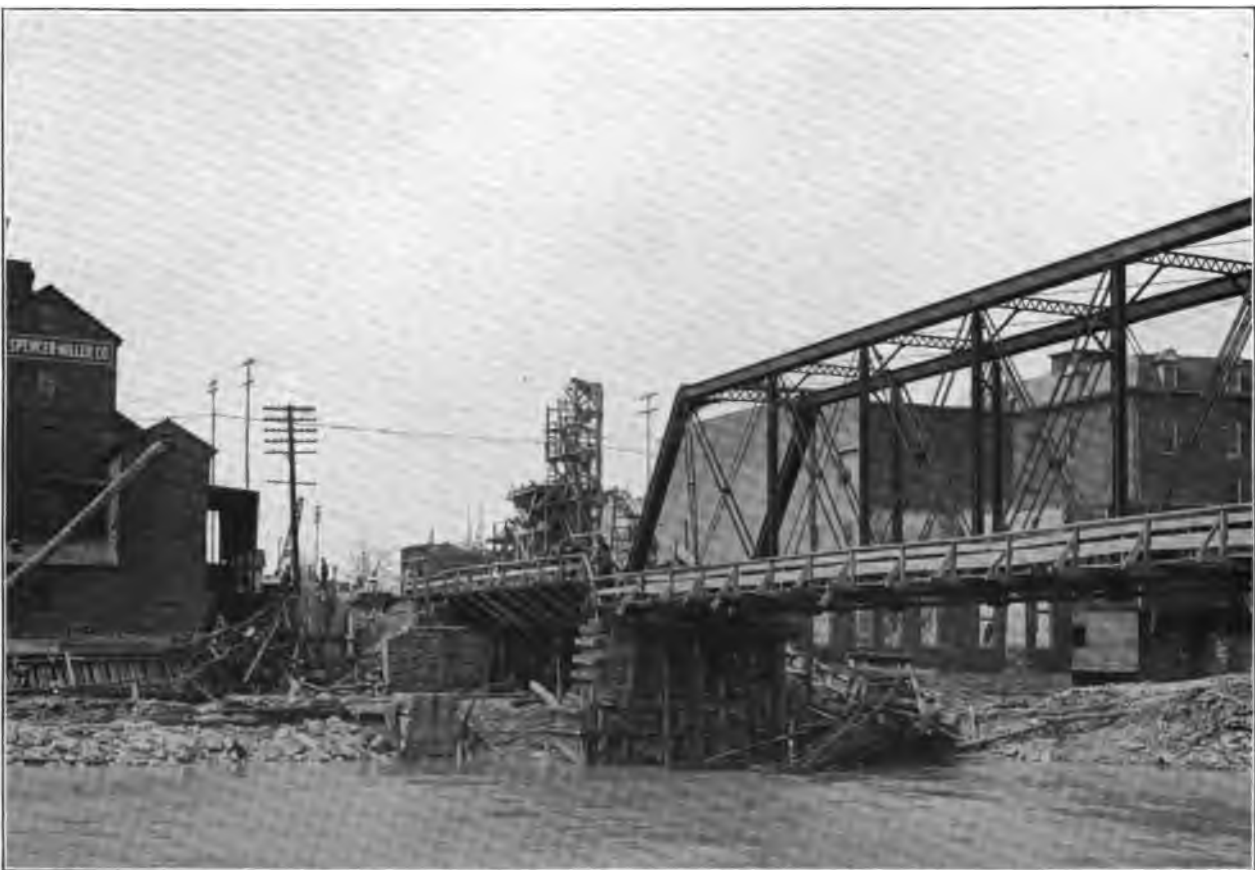
West approach to Bridge 50, looking north; span over Canal, showing damage to other structures near Bridge 50.

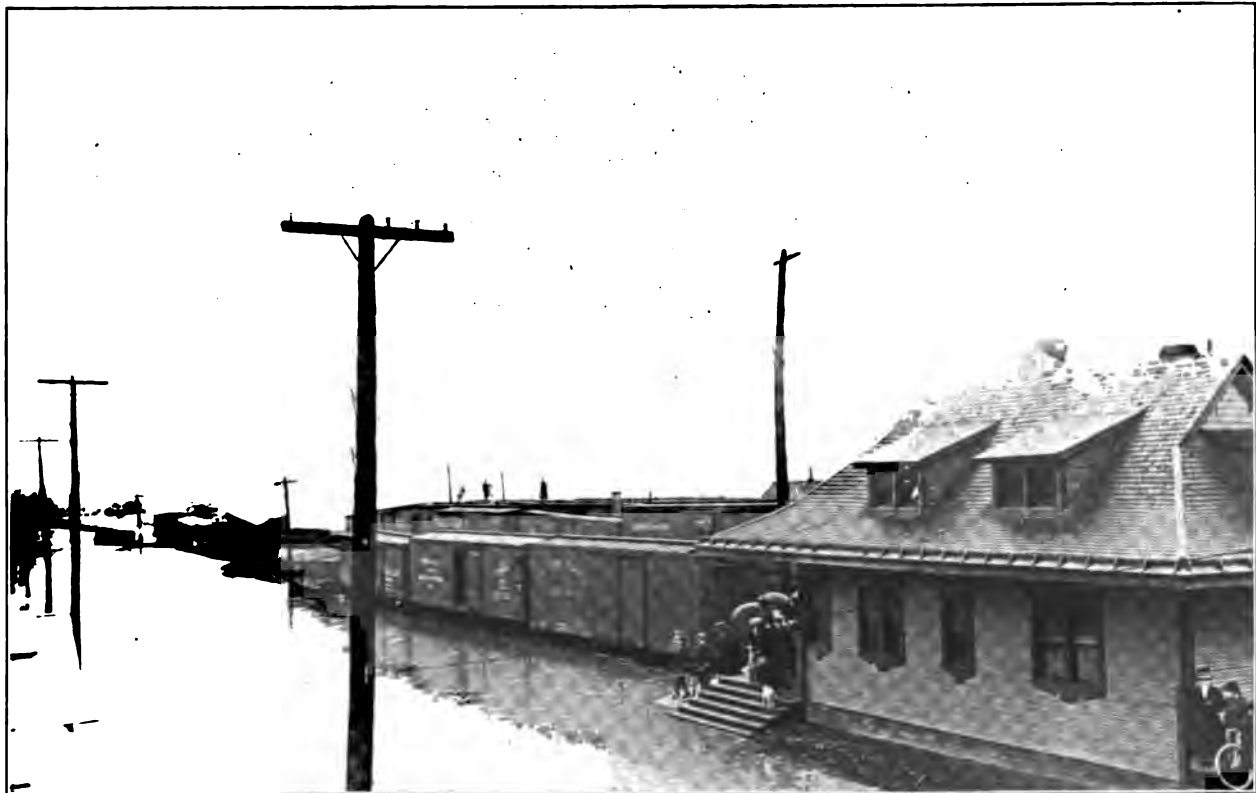
Passenger Station after water had receded about 10 feet. Water had been three inches above the lower belt of light colored brick. The Third Street city bridge and a trolley line bridge spanned the river just beyond the shed left on the tracks.

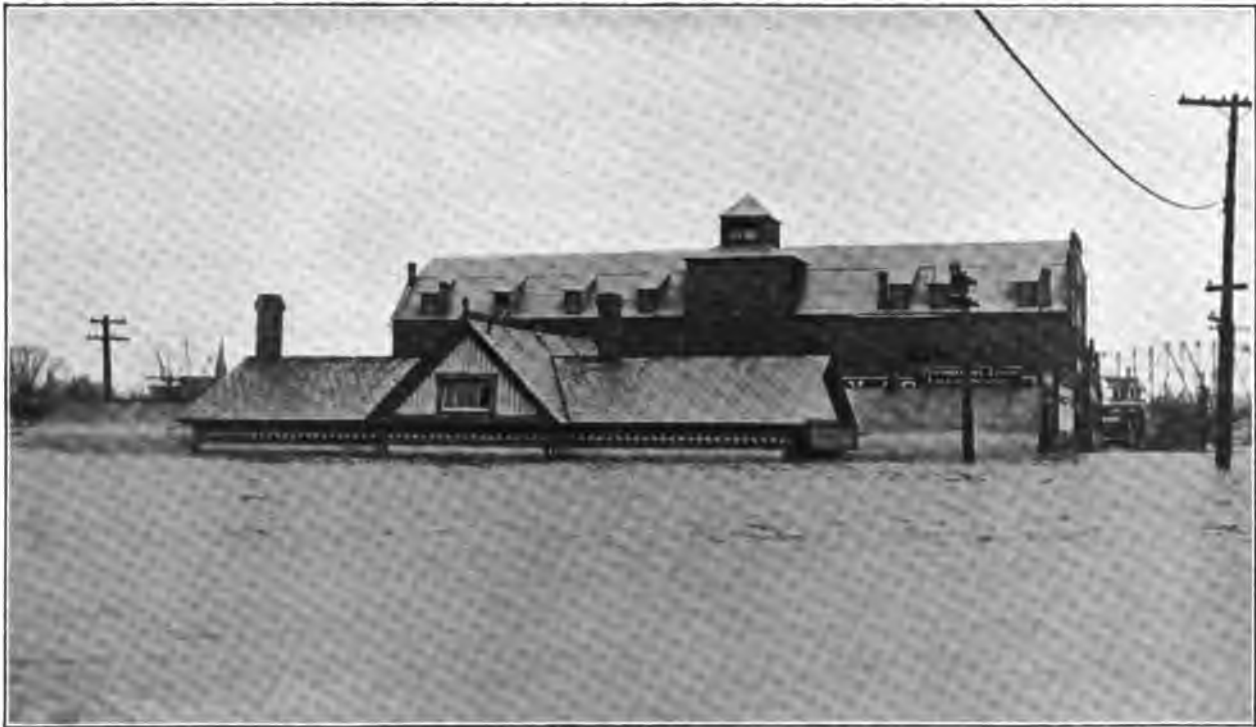
Canal Dover, Ohio.

Marietta Division main track in mid-distance, in front of large building at right; valley of Tuscarawas River.

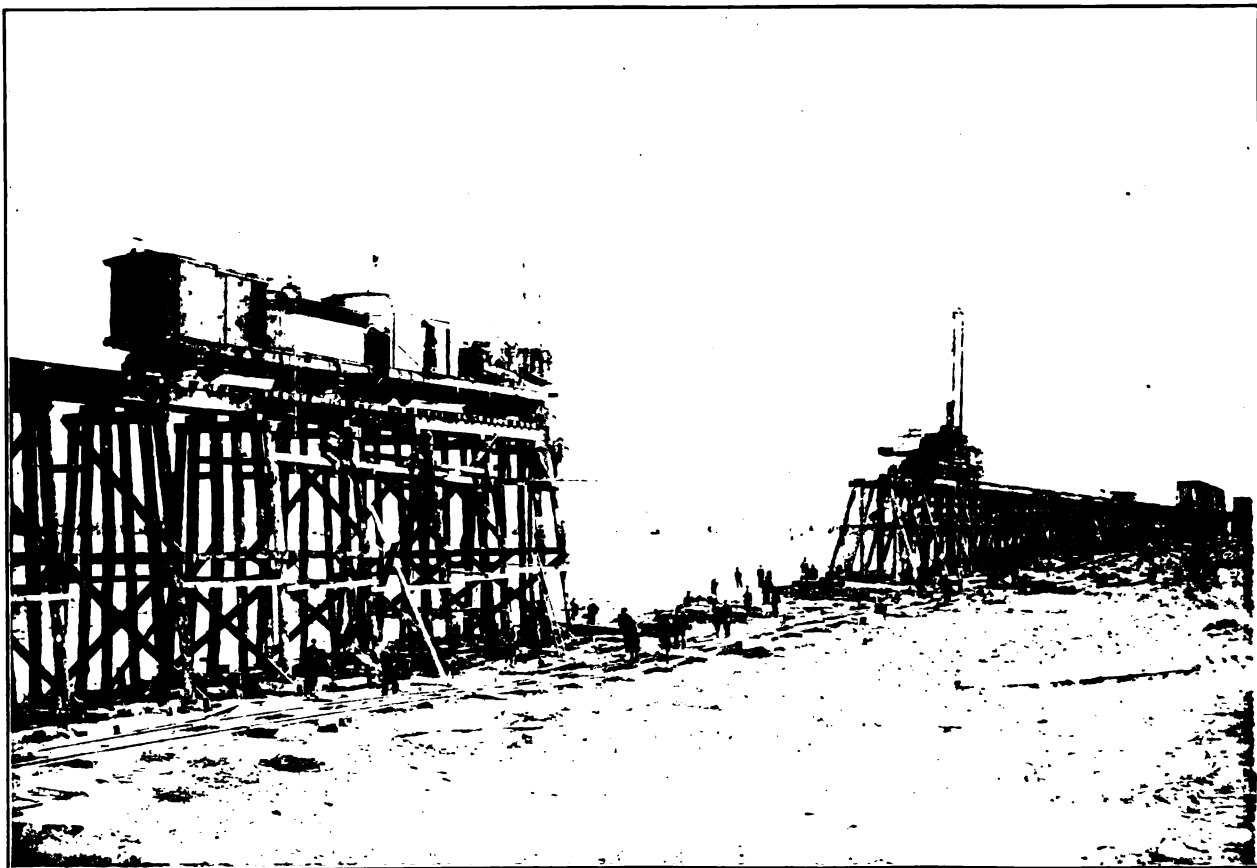
Between Bridges 1 and 2, 1216 feet of trestle washed away. This picture made before repair work was started.

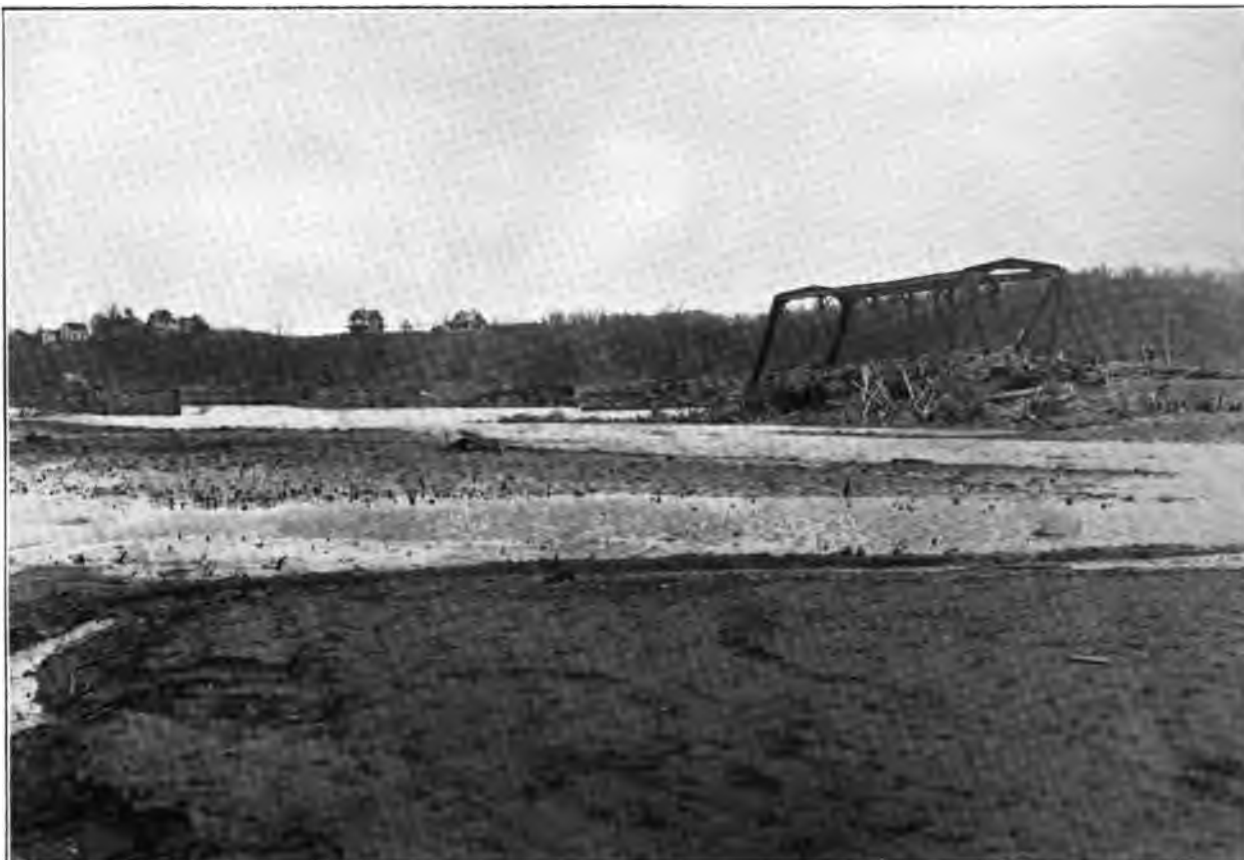
Cavallo, Ohio, east of.

Looking west toward Bridge 18, over Mohican River.
